## **Closed-Circuit Rebreathers in the Forensic Study of the *Rouse Simmons* Shipwreck**

### **Abstract**

The *Rouse Simmons* shipwreck site is located 12 mi (19 km) northeast of Two Rivers, WI, and six miles (10 km) offshore. Project goals were to conduct a Phase II archaeological survey to the level necessary for nomination to the State and National Registers of Historic Places, as well as document any evidence of how and why the *Rouse Simmons* sank.

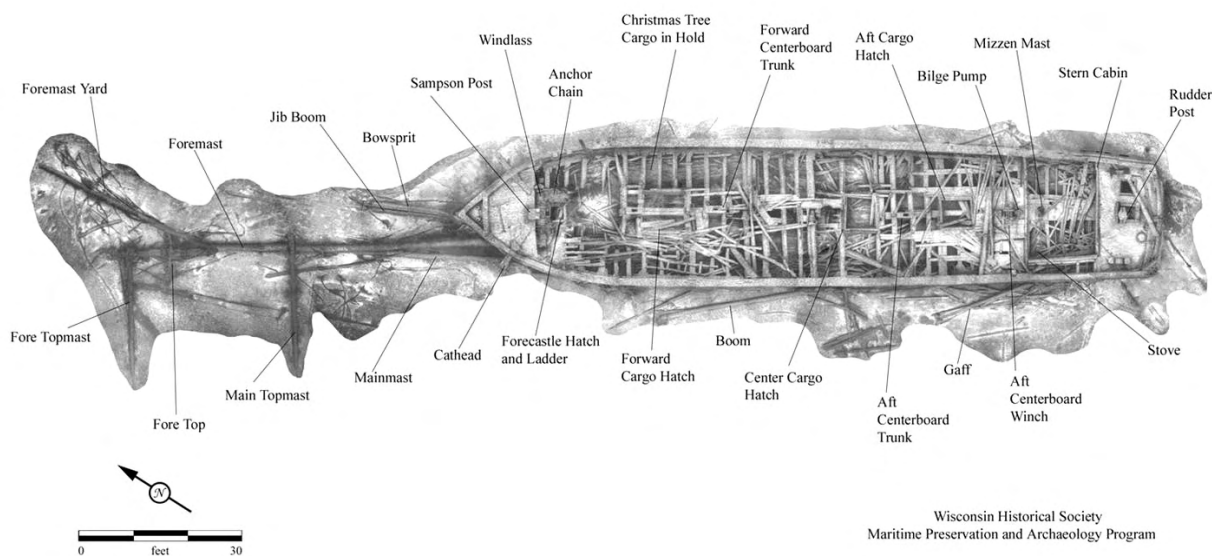
Figure 1. Photomosaic of the *Rouse Simmons* indicating the major features of the wreck

with dead-eyes and lanyards attached to metal chain plates. Each of the three masts was made of two spars: the lower mast and the topmast. The lower and top masts were typically connected together in an overlapping fashion known as the doubling. Nearly all the standing rigging and spars were found just forward of the bow of the wreck (Figures 1 and 3). The following is an overview of the survey results.

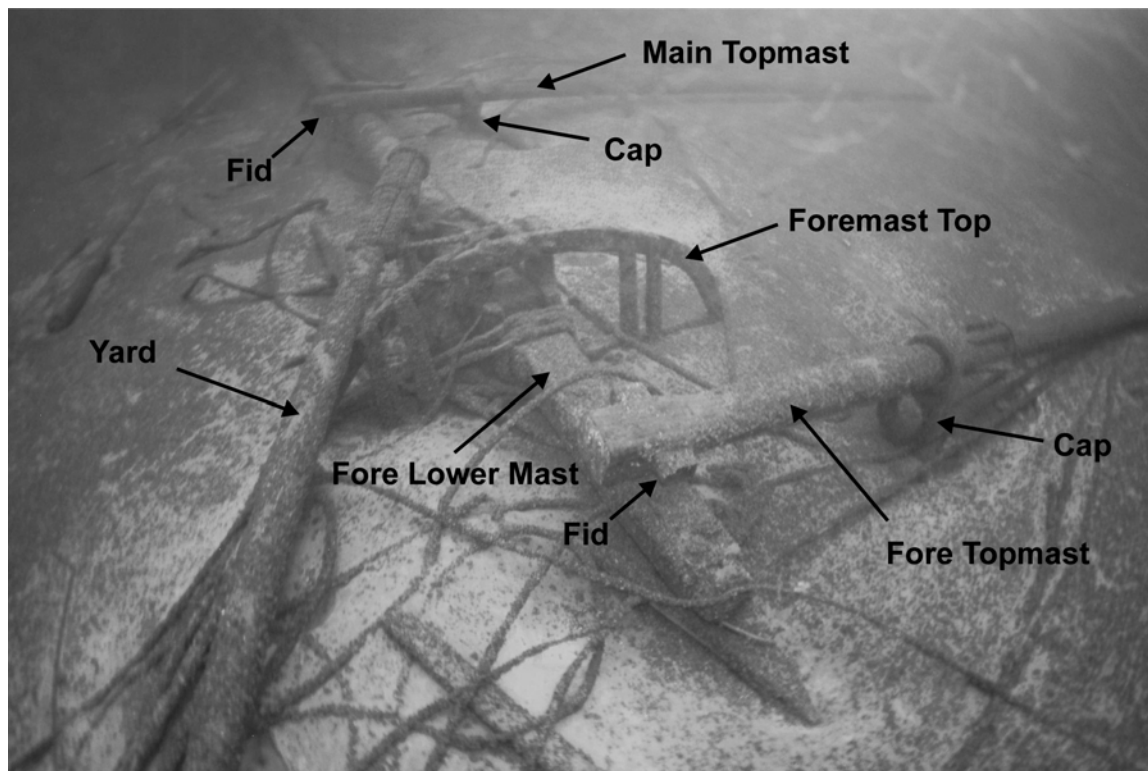
The lower foremast was intact but found lying forward of the hull with the base near the port side bow and angled slightly to the starboard with the mast largely parallel to the hull. A top (platform) was found in place on the lower foremast. The fore lower yard was still attached to the lower mast by the metal truss, which was severely bent on one side. The yard was broken at one end and the piece missing. The fore topmast appeared to be intact, its base lying near the top end of the lower mast at a 90° angle. The upper end was buried deeply in the silt and could not be observed. The hardware that connects the topmast to the lower mast (fid and cap) were intact and in place. The lower end of at least some of the wire rope topmast shrouds appeared to be still connected to the futtock shrouds. The futtock shrouds were made of solid round metal stock approximately 1.0 inch (2.54 cm) in diameter and appeared to have turnbuckles forged onto them. They were deformed and bent. The main lower mast was found on the forward port side of the hull, slightly aft and generally parallel to, and underneath the foremast. The base of the main lower mast could be examined only by touch because it is buried in silt appeared to be incomplete. Crosstrees were found and a top (platform) was not present. The main topmast was found lying over both the fore lower mast and the main lower mast. It was completely intact as were the fid and mast cap. Heavy wire standing rigging was found loosely looped around the topmast and appeared to extend under the silt to the underside of the buried main lower mast (Figure 3).

Figure 3. Rigging deposited off the bow (upper left) of the vessel, showing top masts perpendicular to the foremast. The top on the lower foremast can be clearly seen. The main mast is buried below the foremast and cannot be seen in this photo. The main top mast is shown held perpendicular to the foremast in the background. The cap and fid of each topmast can be seen. The diagonal spar in the left foreground is the broken yard used for the Raffee sail. (photo by T. Thomsen)

The standing rigging of a ship is a system integrated with the masts and the hull. Under stress, rigging failures can lead to dismasting and weaknesses in the wooden masts can lead to rigging failures. Wood rot in the masts or corrosion of wire standing rigging are potential weaknesses of a wooden ship of this type. However, it would be unlikely to find evidence of rot or corrosion this long after the wreck. Otherwise, under stress, the failure points are the connections of the standing wire rigging to the chain plates which was accomplished by hemp lanyards threaded through the dead-eyes. Other than the bowsprit/jib boom, we found no evidence of standing rigging still attached to hull chain plate dead eyes by hemp rope, nor did we find standing rigging positioned near hull chain plates. Instead, all of the masts and standing rigging appeared to have been thrown forward of the hull in a relatively small area (Figures 1 and 3).

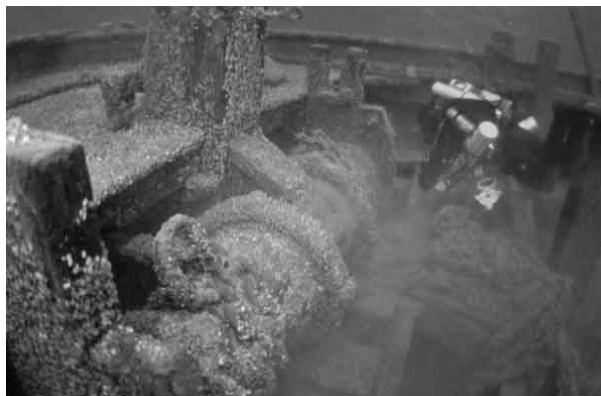
There is evidence that the port anchor was being prepared for deployment. The four turns of the starboard anchor chain have been loosened around the windlass barrel, gathered, and tied to the strongback that was affixed atop the windlass. The anchor chain has rusted into its tied-up position, and fragments of the fiber line that tied the chain is visible protruding from the chain links. One of the four turns of the port anchor chain is run through an iron Norman Pin that is embedded into the windlass barrel (Figure 4). The Norman Pin (shaped like a large iron staple) was used as a chain stopper prior to modern iron stoppers with a swinging iron gate. Once an anchor was deployed, the Norman Pin was driven into the windlass to lock down the anchor chain, preventing further deployment of chain, and took the strain off the wooden windlass pawl. The Norman Pin is in place at the ready, but has not been driven into windlass to lock down the chain.

Figure 4. The windlass showing the Norman Pin (inverted u-shaped metal in lower left). (photo by T. Thomsen)

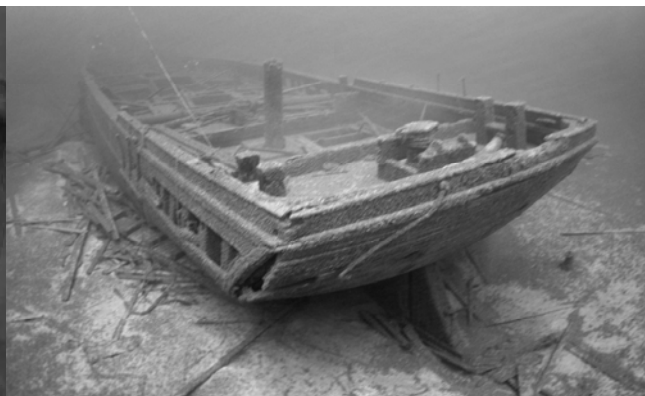
The *Rouse Simmons's* hull is largely intact and lies on an even keel. With the exception of the port and starboard quarters, all outer hull planking was intact with caulking. Outer hull planks not colonized by zebra and quagga mussels exhibit traces of green and blue paint. The only visible damage to the outer hull was located at the stern. Both port and starboard quarters had several outer hull planks missing immediately forward of the transom (Figure 5). The missing planks were located above the water line. The transom is dislodged on the port side, pushed several inches outward from the hull.

Figure 5. The stern of the ship showing damage to the port side of the transom. The stump of the mizzen mast can be seen. (photo by T. Thomsen)

relatively small area immediately forward of the wreck as reflected in our survey. As the ship sank, air pressure grew in the stern of the hull, further tilting the bow downward. Air pressure trapped in the stern of the wreck escaped through the transom, partially dislodging the transom and several outer hull planks as evidenced by the transom damage (Figure 5).
