## **Closed-Circuit Rebreathers in the Forensic Study of the *Rouse Simmons* Shipwreck**

### **Abstract**

The *Rouse Simmons* shipwreck site is located 12 mi (19 km) northeast of Two Rivers, WI, and six miles (10 km) offshore. Project goals were to conduct a Phase II archaeological survey to the level necessary for nomination to the State and National Registers of Historic Places, as well as document any evidence of how and why the *Rouse Simmons* sank.

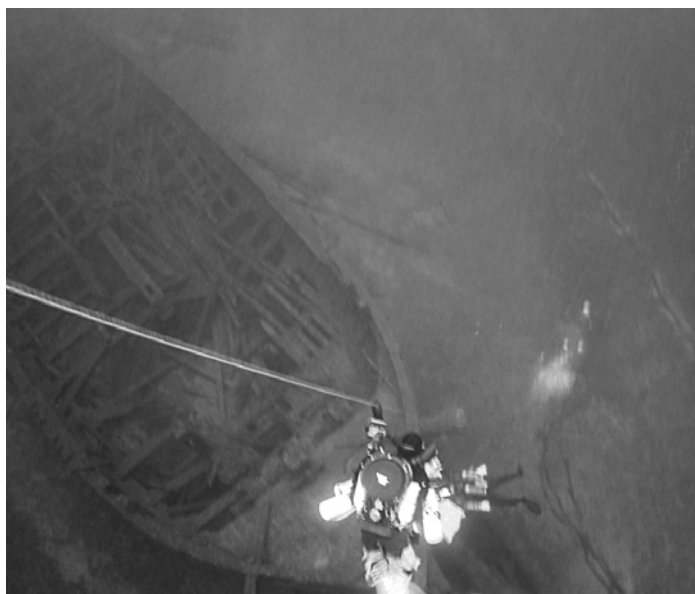
Figure 2. Two CCR divers descend to the wreck showing the generally good visibility at the site during the survey. The bow of the wreck is clearly visible as is an open-circuit diver to the right of the wreck. (photo by T. Thomsen)
